# Surface damage of rolling contacts caused by discrete current flow

von T. Zika, F. Buschbeck, G. Preisinger, I.C. Gebeshuber, M. Gröschl\*)

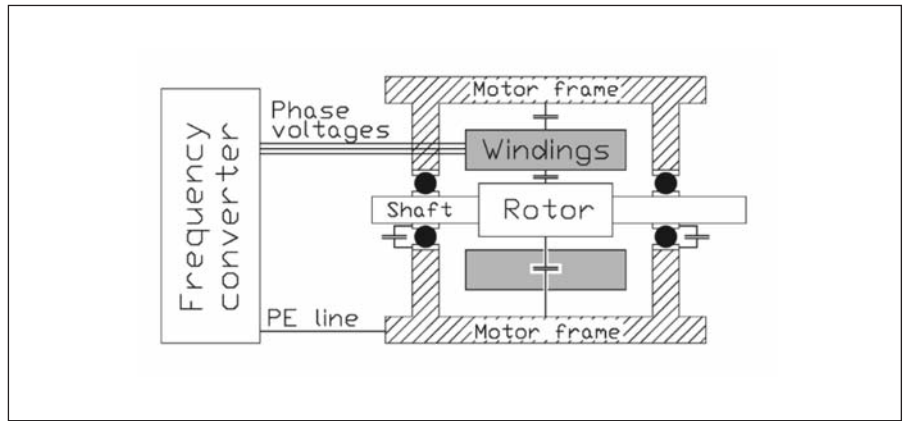
**Figure 1:** Inherent stray capacitances in a three-phase induction motor driven by a frequency converter

The voltage signals delivered to the electric machines are generated by pulse width modulation (PWM) and contain voltage pulses of high slew rates (typically 2-10 kV/μs). This, in combination with inherent parasitic stray capacitances between major elements (e.g. frame to winding ..., see **Figure 1**) insi-

de the electric machine, causes current flow according to  $I = C \cdot dV/dt$ . Many different current paths are possible inside such a machine. Some of them unfortunately include the bearings, which depending on their actual impedance [10] might eventually get harmed by active current flow. In these modern drive systems the current flow, and hence the deposition of harmful energy, is not continuous anymore, but a discrete process. In worst case it is repeated with every switching operation of the frequency converter.

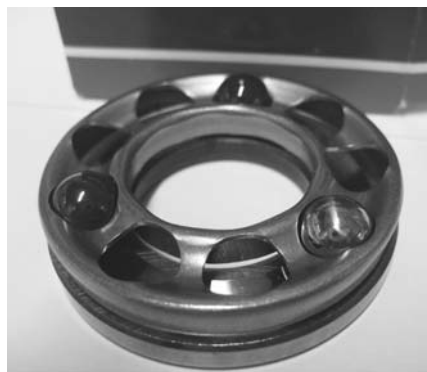
**Figure 2:** Test bearing consisting of one steel test RE and two ceramic supporting RE

The test bearings were modified bearings of SKF type 51305. Instead of nine rolling elements (REs) made of 100Cr6 bearing grade steel only three rolling elements were used: one test rolling element made of electrically conductive bearing grade steel, the two other supporting elements made of insulating silicon nitride as used in hybrid ball bearings (see **Figure 2**). Subsequently, there was only one distinct current path connecting the two washers of the bearing, namely through the one conductive rolling element. All test bearings were lubricated with the same out-of-the-shelf grease consisting of a mineral base oil and lithium soap thickener. The actual test specimen, which later was analysed, was the one steel rolling element. Therefore, in course of a test series not the whole test bearing was exchanged, but only the steel rolling element was replaced (washers and cage were left unchanged).

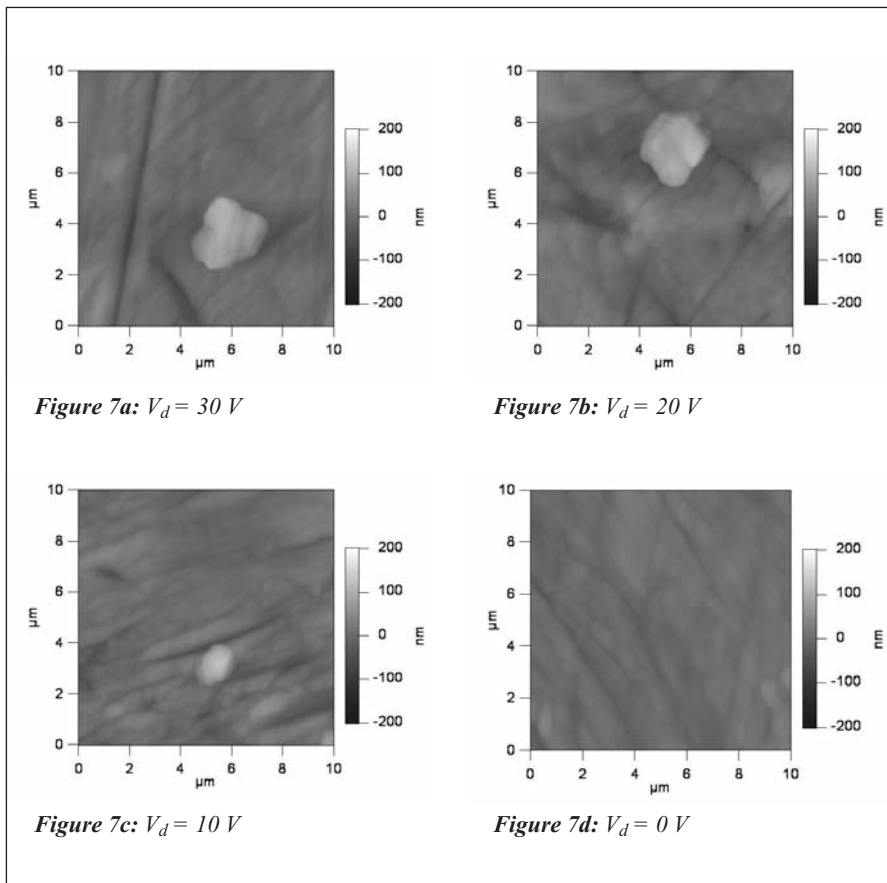
**Figure 7:** AFM topography of RE samples created with different levels of driving voltage and, hence, bearing current intensity. Rotational speed  $n = 1000 \text{ rpm}$

Furthermore samples, all tested using a rotational speed of 1000 rpm, with various electric driving voltages are compared. In **Figure 7**, single distinct damage features of the surface topography are shown. Generally, the biggest sized features found on the sample surface were chosen for display. These features are more likely created by a current pulse with an intensity similar to the measured maximum current. Based on the topography the extent of the damage is calculated and values for the samples shown in **Figure 7** are given in **Table 1**.

Sample	Maximum current flow [A]	Approximate diameter [ $\mu\text{m}$ ]	Area [ $\mu\text{m}^2$ ]
$V_d = 30 \text{ V}$ (Fig. 7a)	2.17	3.0	5.00
$V_d = 20 \text{ V}$ (Fig. 7b)	1.45	3.0	4.92
$V_d = 10 \text{ V}$ (Fig. 7c)	0.70	1.6	1.51

The comparison of samples with different driving voltages and, hence, different current intensities shows the expected trend (**Figure 7** and **Table 1**): the features become bigger in size with increasing current intensity. This is especially valid for the samples with 10 V and 20 V of driving voltage. The difference between the samples with 20 V and 30 V is only marginal. However, it has to be noted that there was no possibility for exact determination of the particular current pulse intensity associated with the displayed craters. So it is not sure that the displayed crater represents one that was created with a current pulse close to the maximum measured value.
